# The HyMoCARES project: improving hydromorphological management of alluvial rivers

Andrea Goltara – Italian Centre for River  
Restoration (CIRF)

Workshop on Implementation of  
Nature-based Solutions to tackle climate change

# (1) Restoration of the Rio Mareta

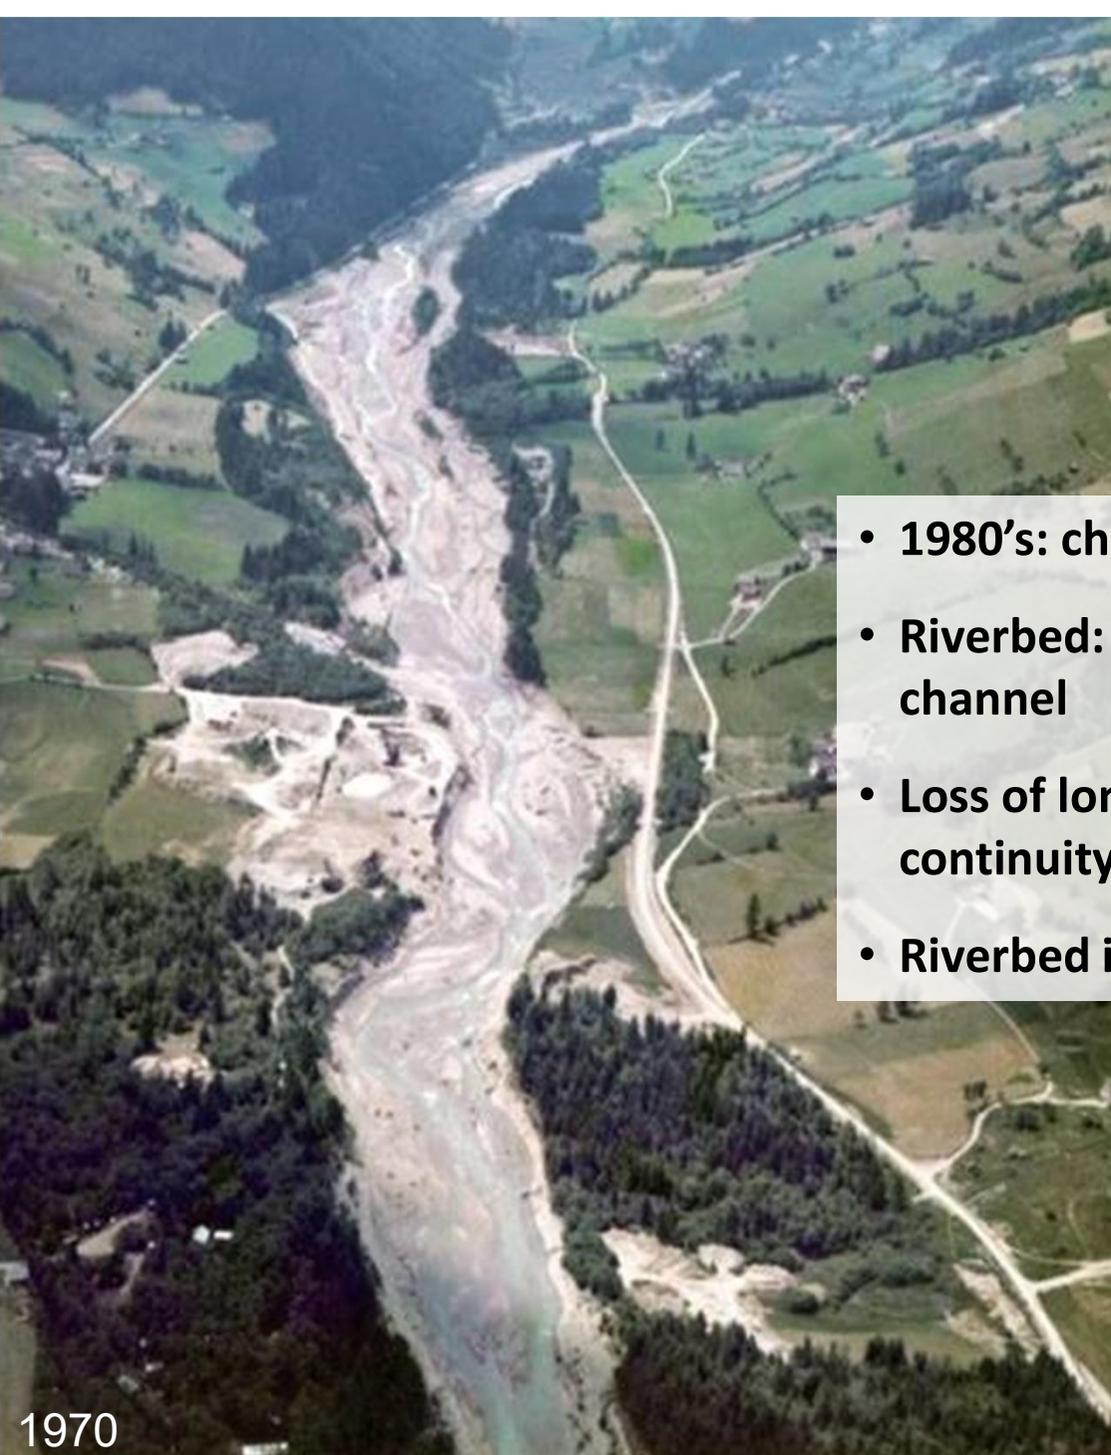
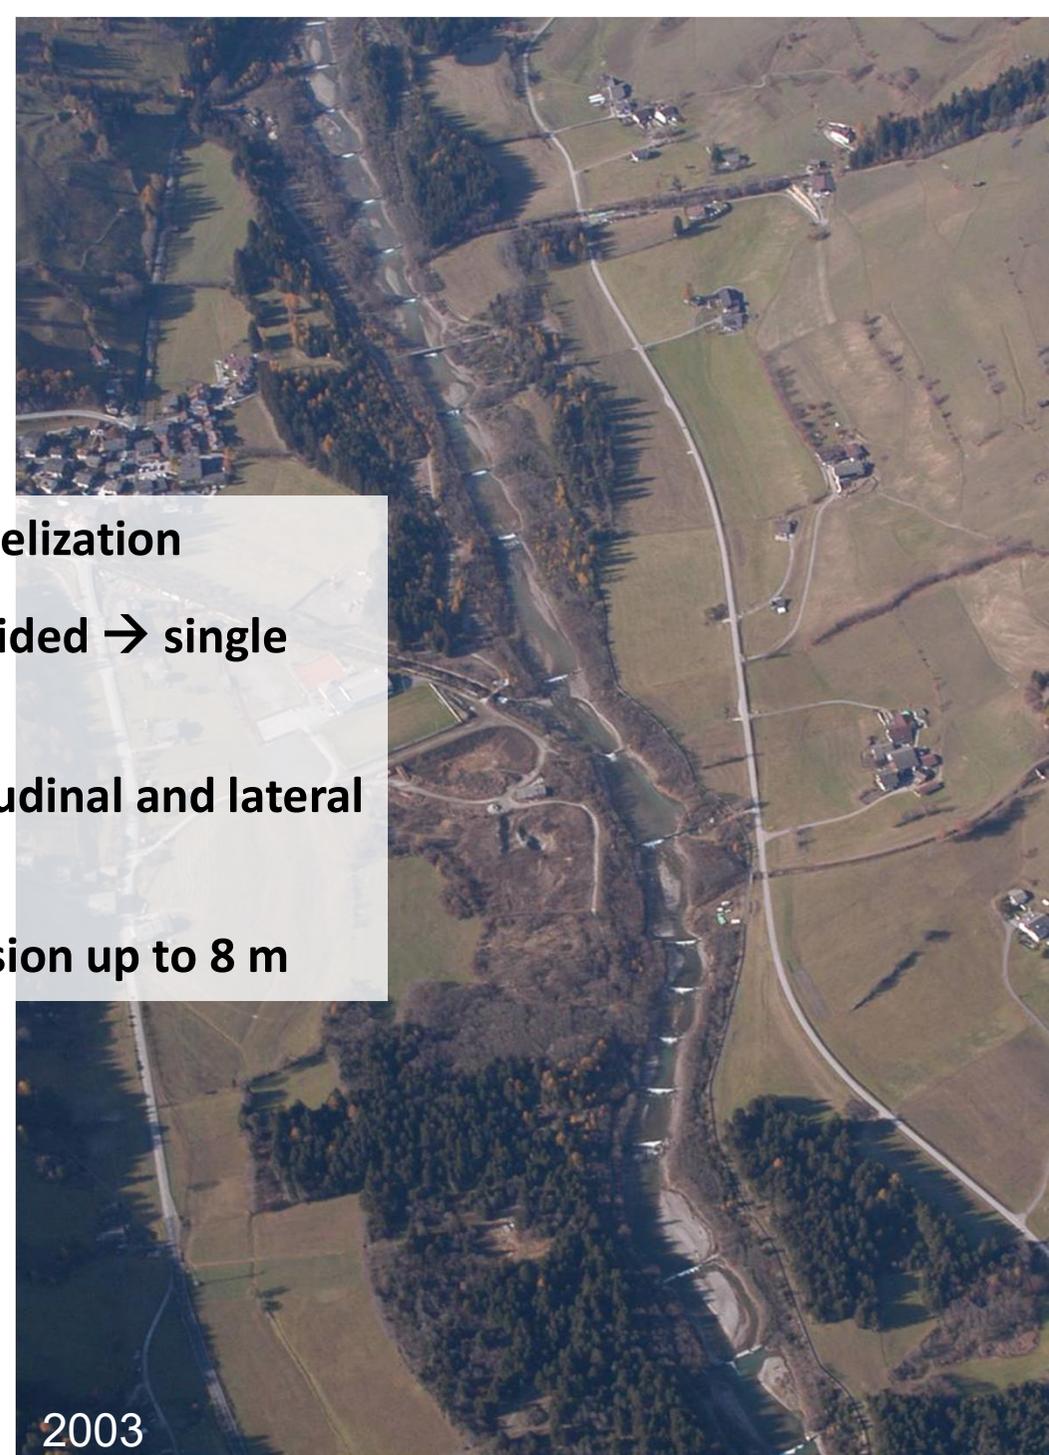
- **1980's: channelization**
- **Riverbed: braided → single channel**
- **Loss of longitudinal and lateral continuity**
- **Riverbed incision up to 8 m**

1970

2003

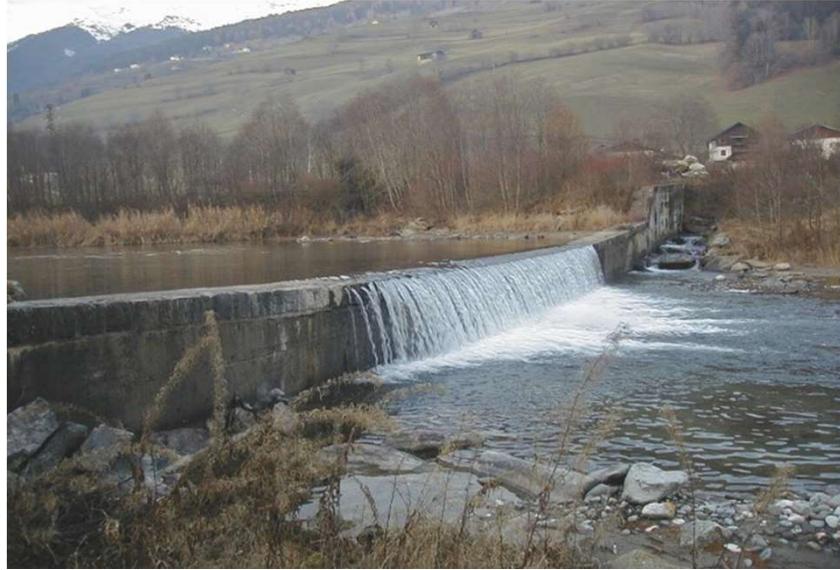
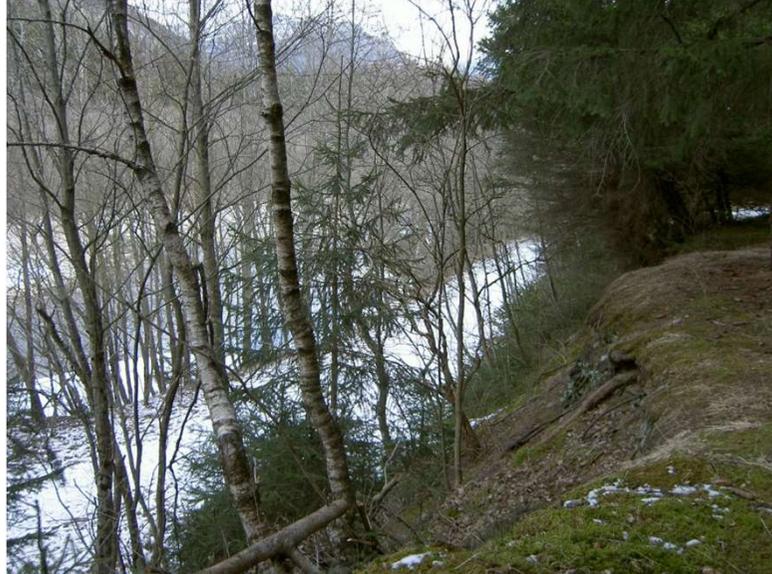
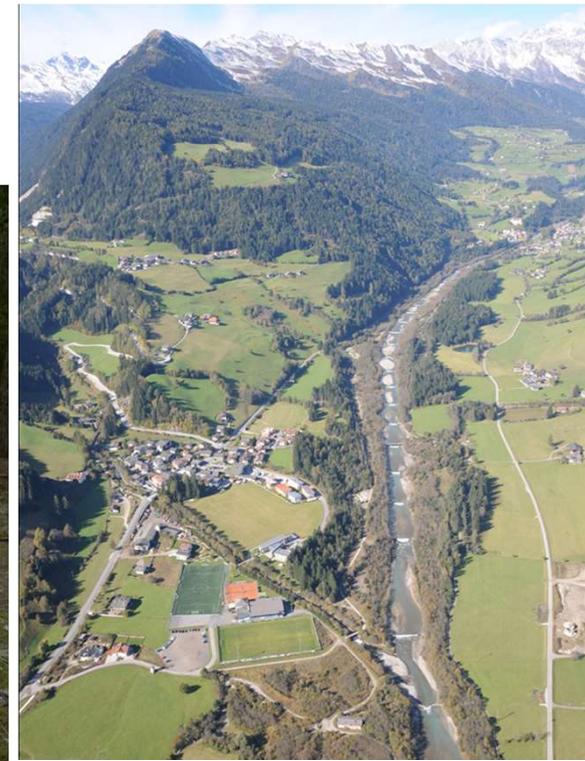
# POOR ECOLOGICAL CONDITIONS

- **Lack of connectivity**
- **Lowering of the water table**
- **Loss of 88% of instream and riparian habitats**

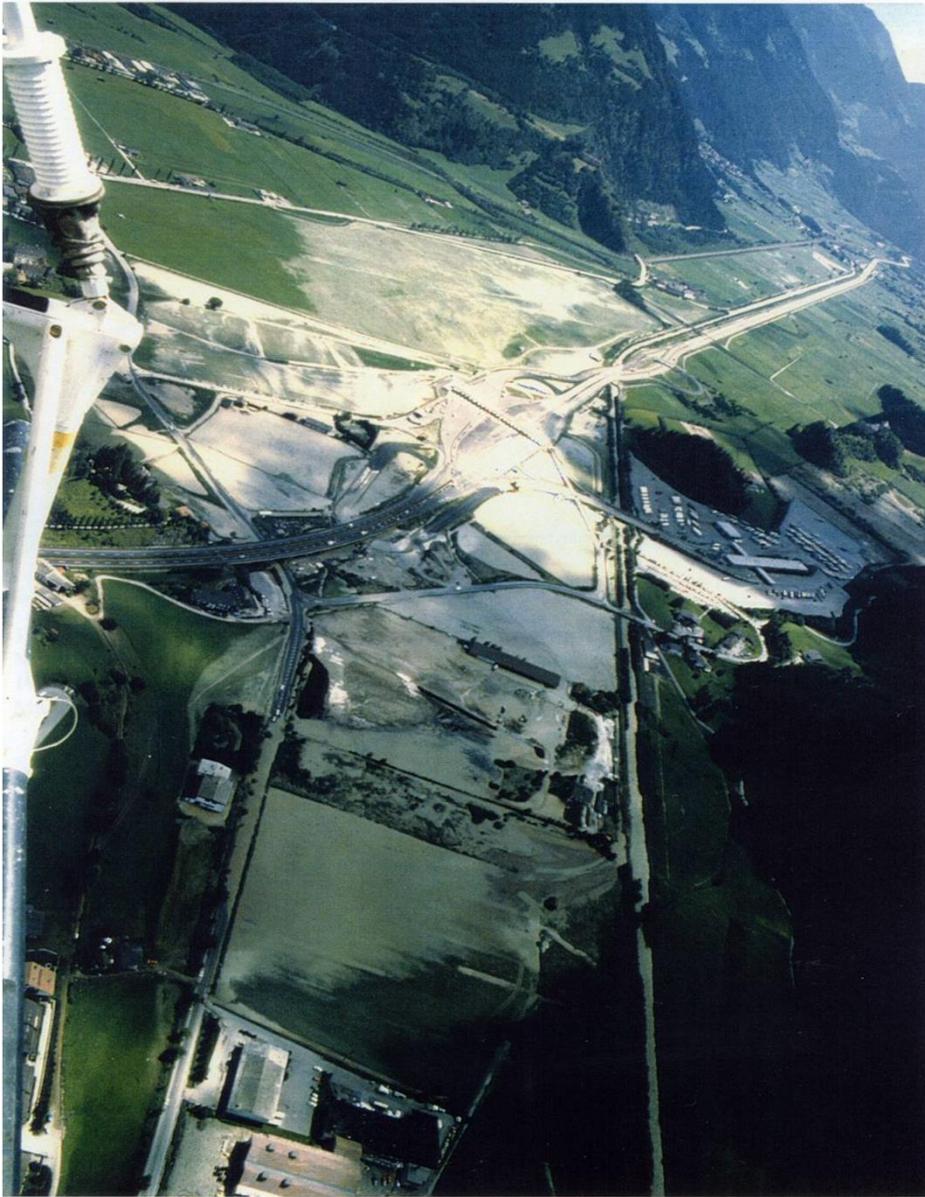
# FLOOD RISK downstream

Vipiteno plain: 1985, 1987 (picture) and 1991

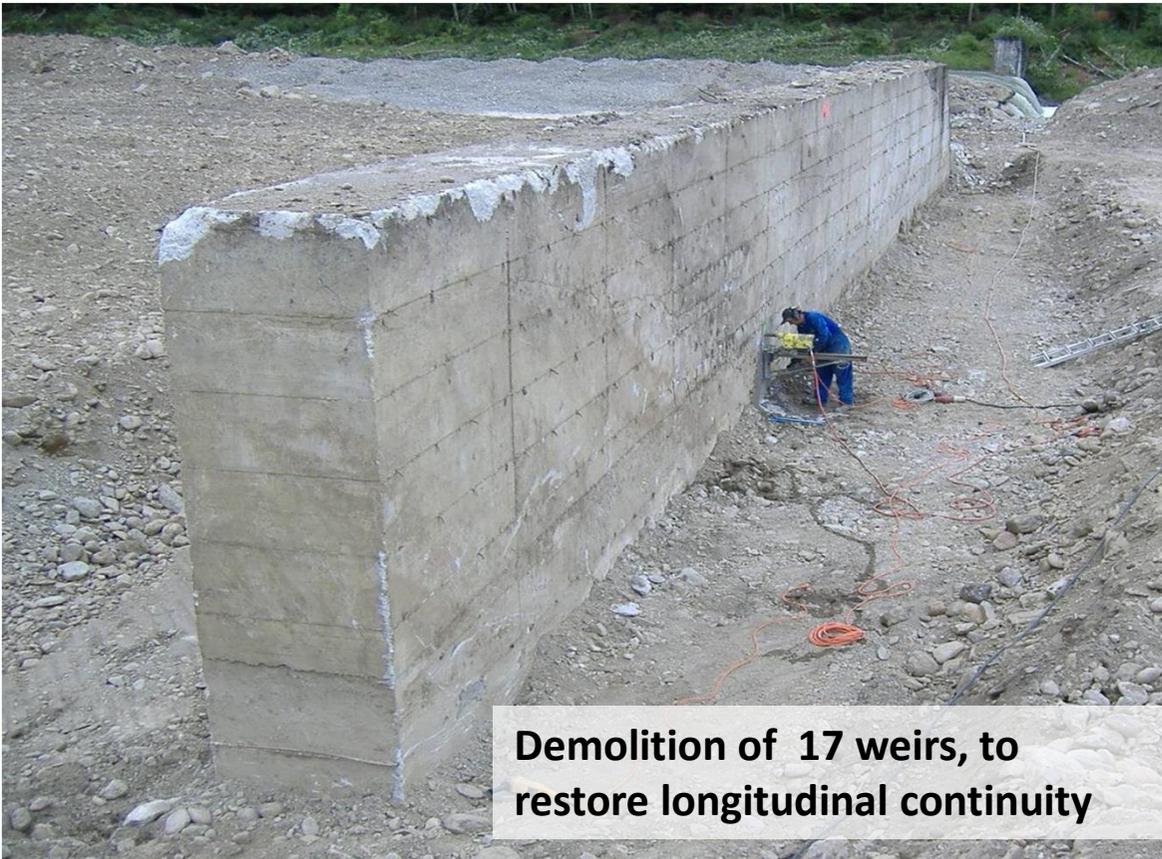
**Demolition of 17 weirs, to restore longitudinal continuity**

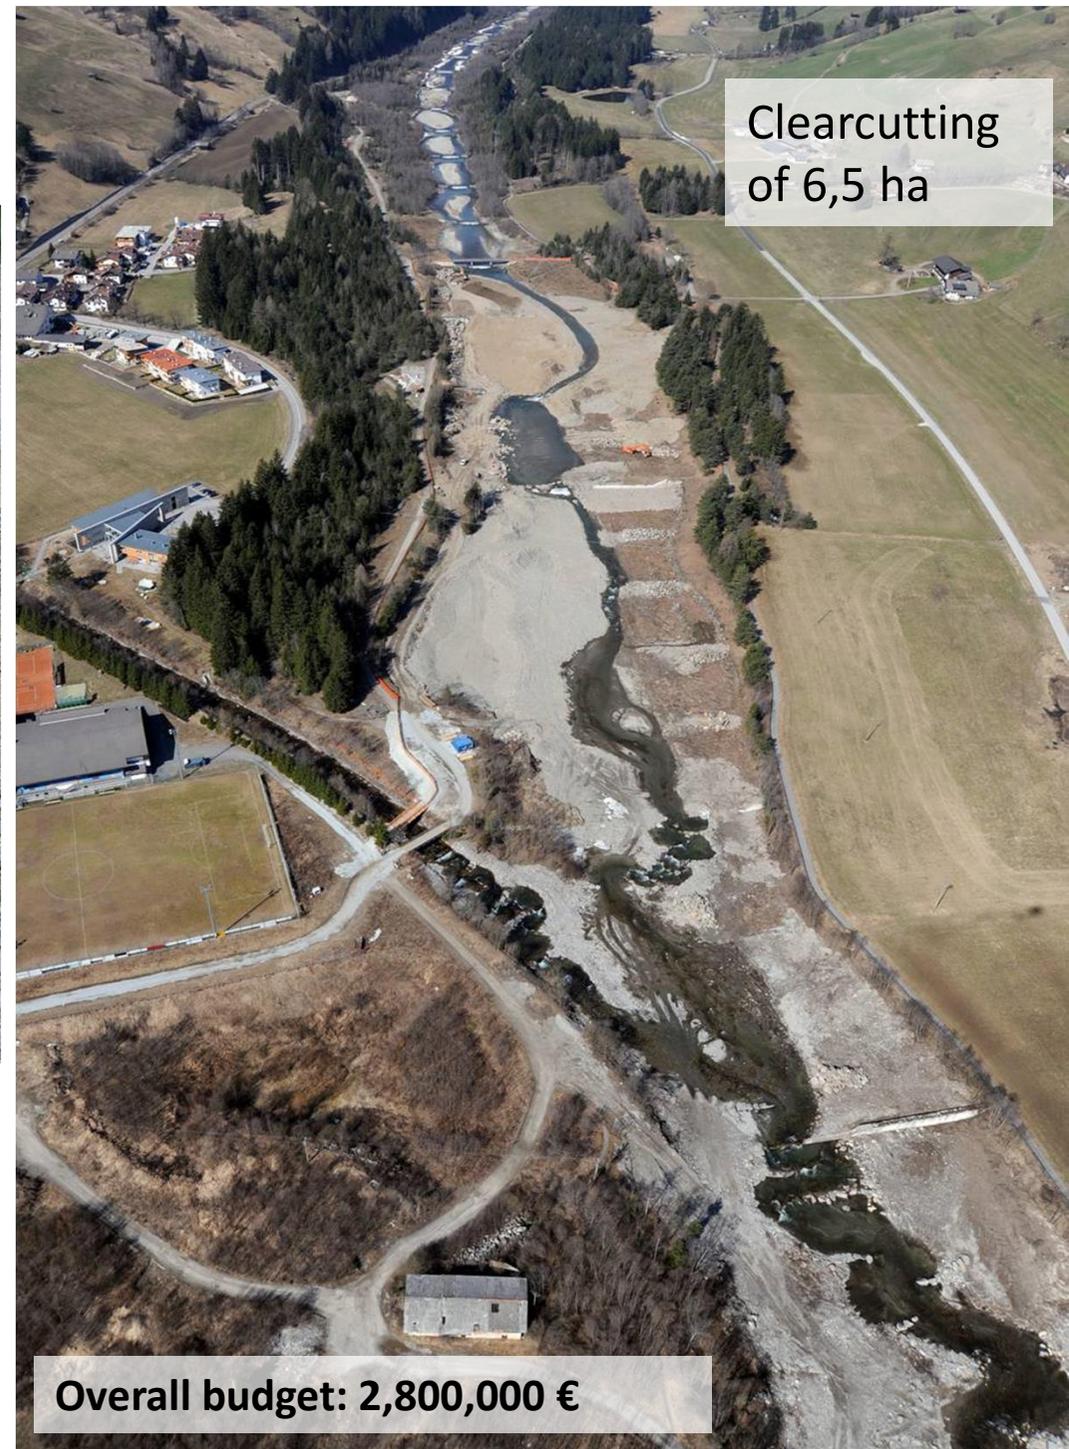
Clearcutting of 6,5 ha

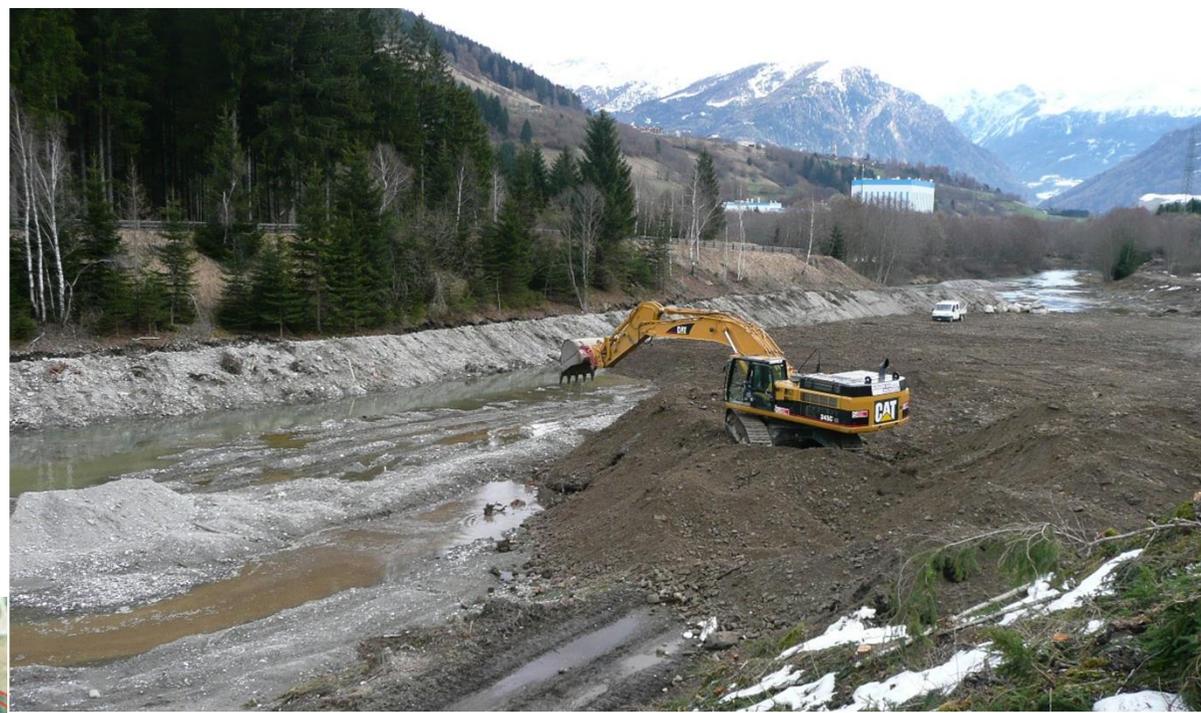
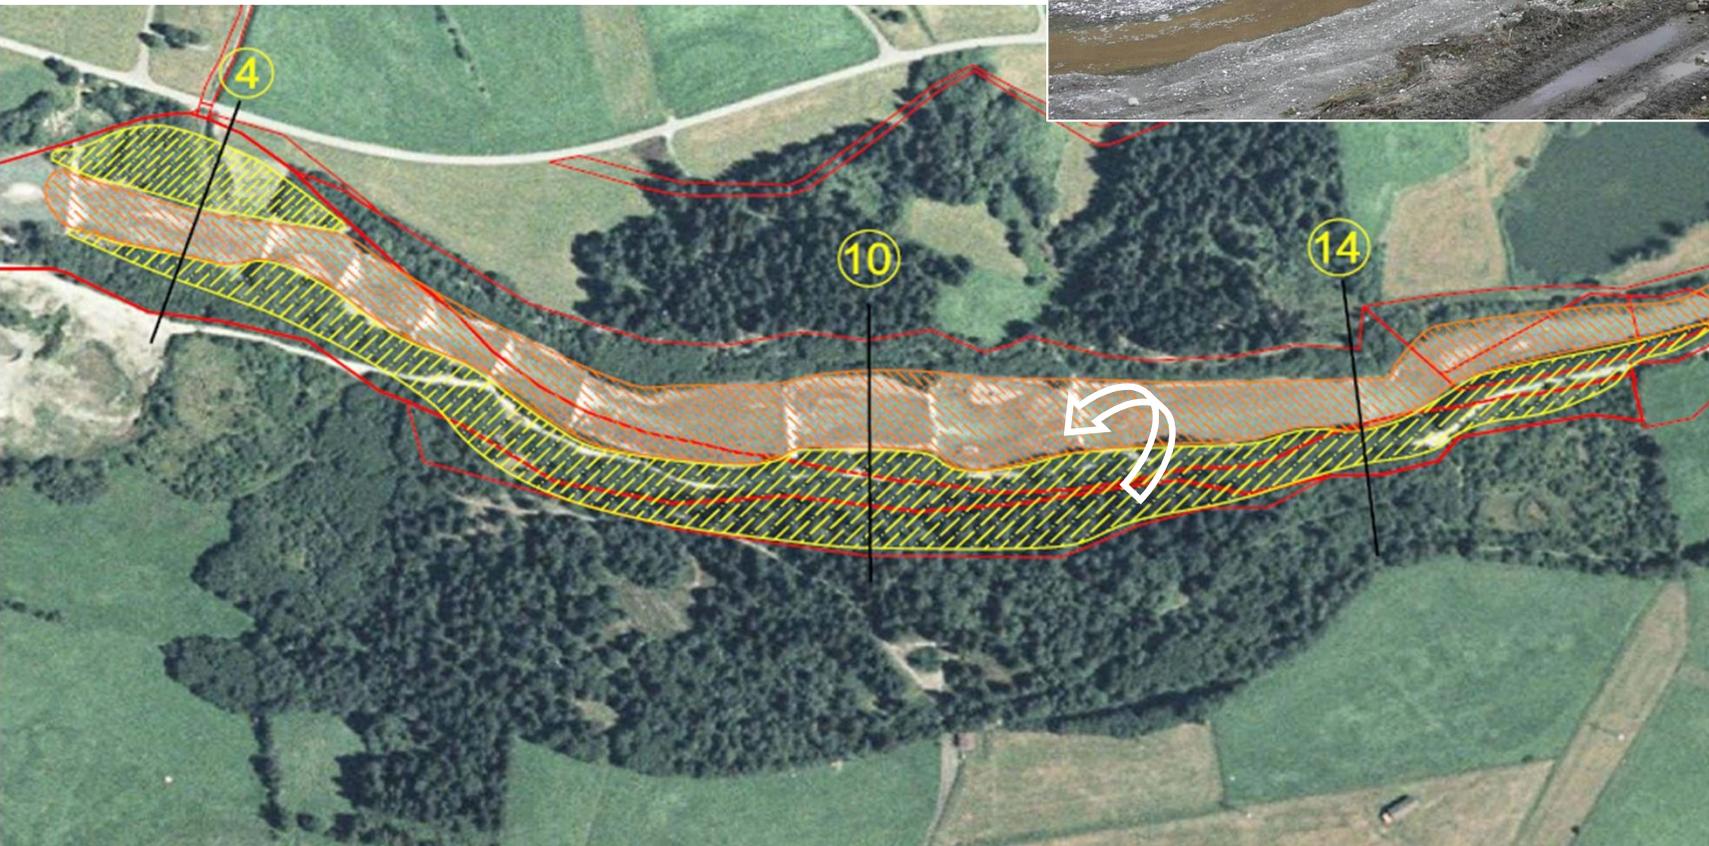
Reintroduction of 130.000 m<sup>3</sup> of gravel (taken on site) to raise the riverbed.

Overall length of restoration approx. 2 km

Public domain
-

Excavation
-

Reintroduction

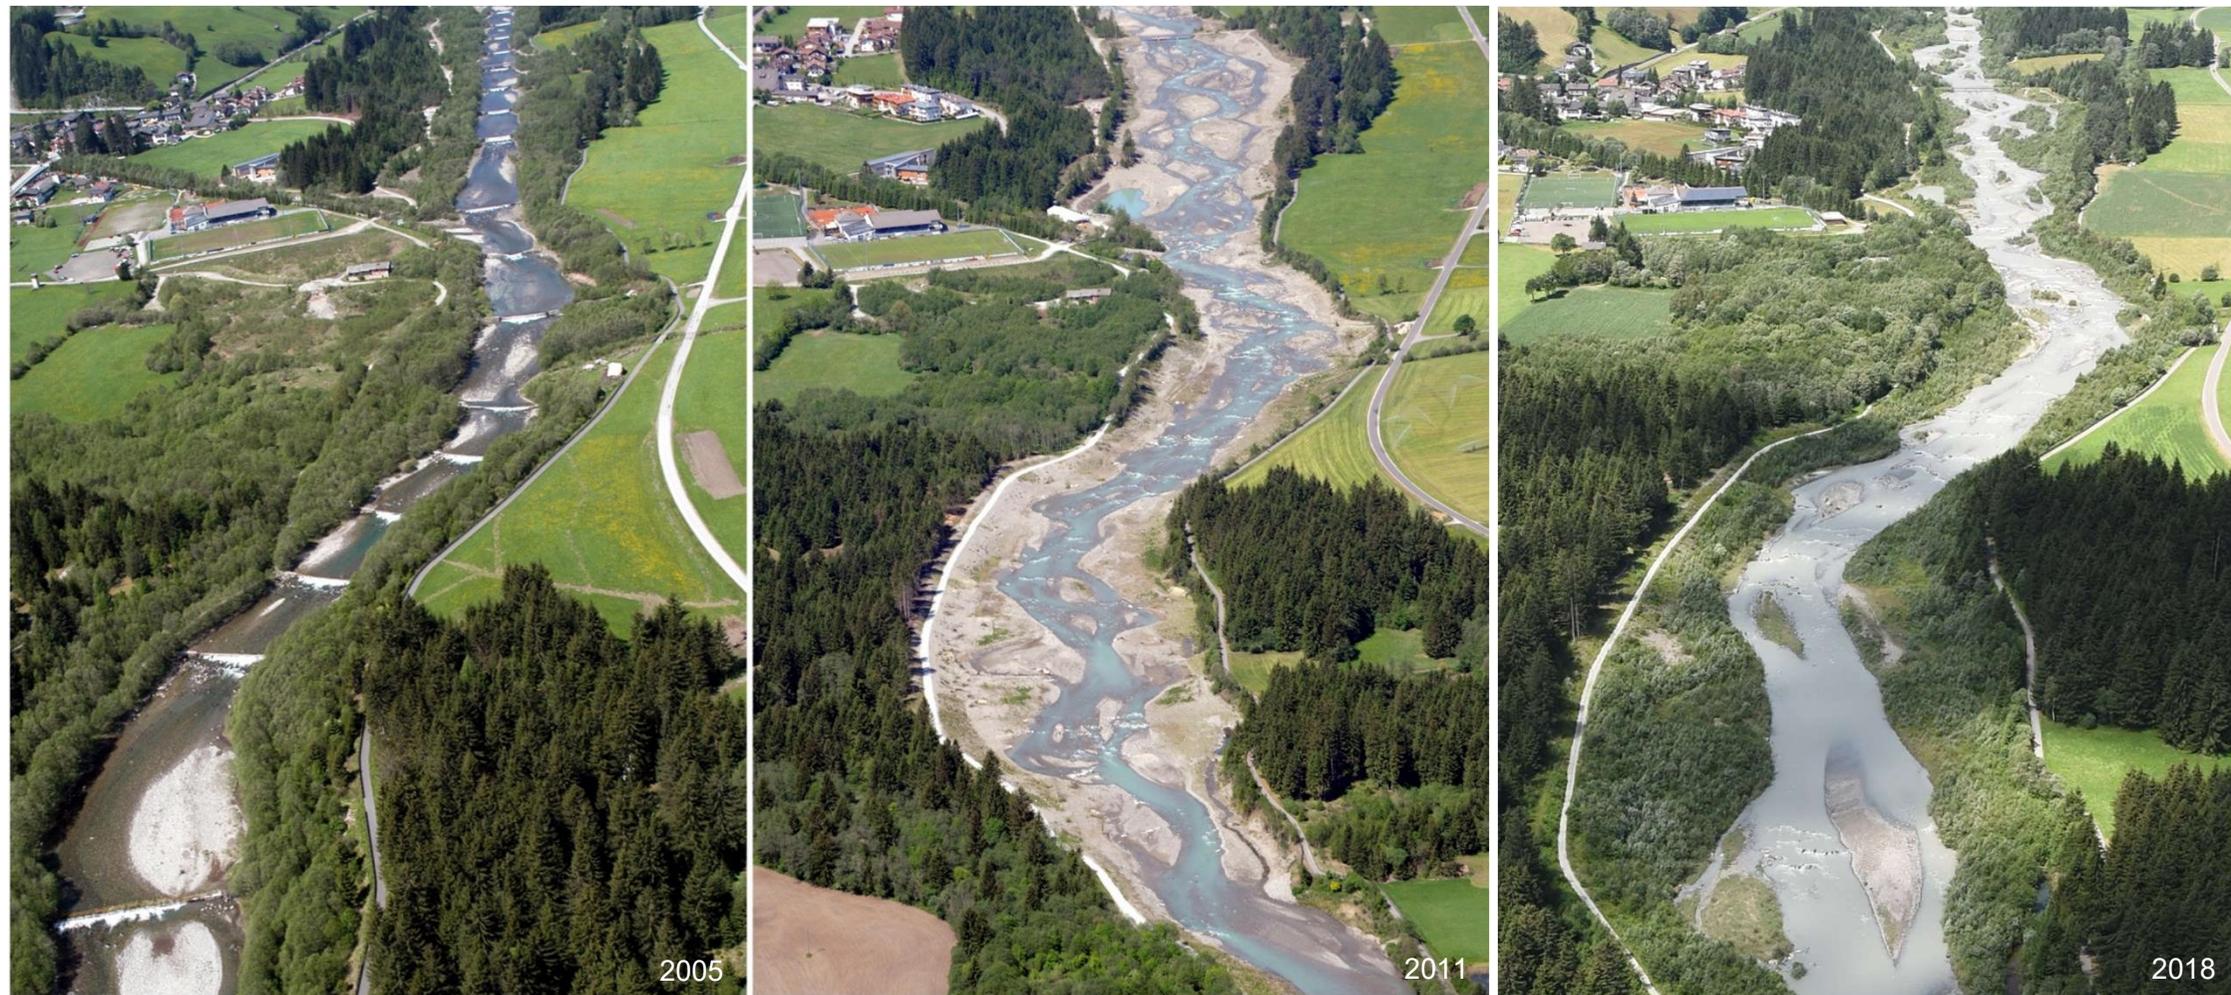
Before the works

1 year after the works

8 years after the works

Braided, riverbed width doubled in comparison to pre-project conditions  
(ensuring increased flood retention capacity)

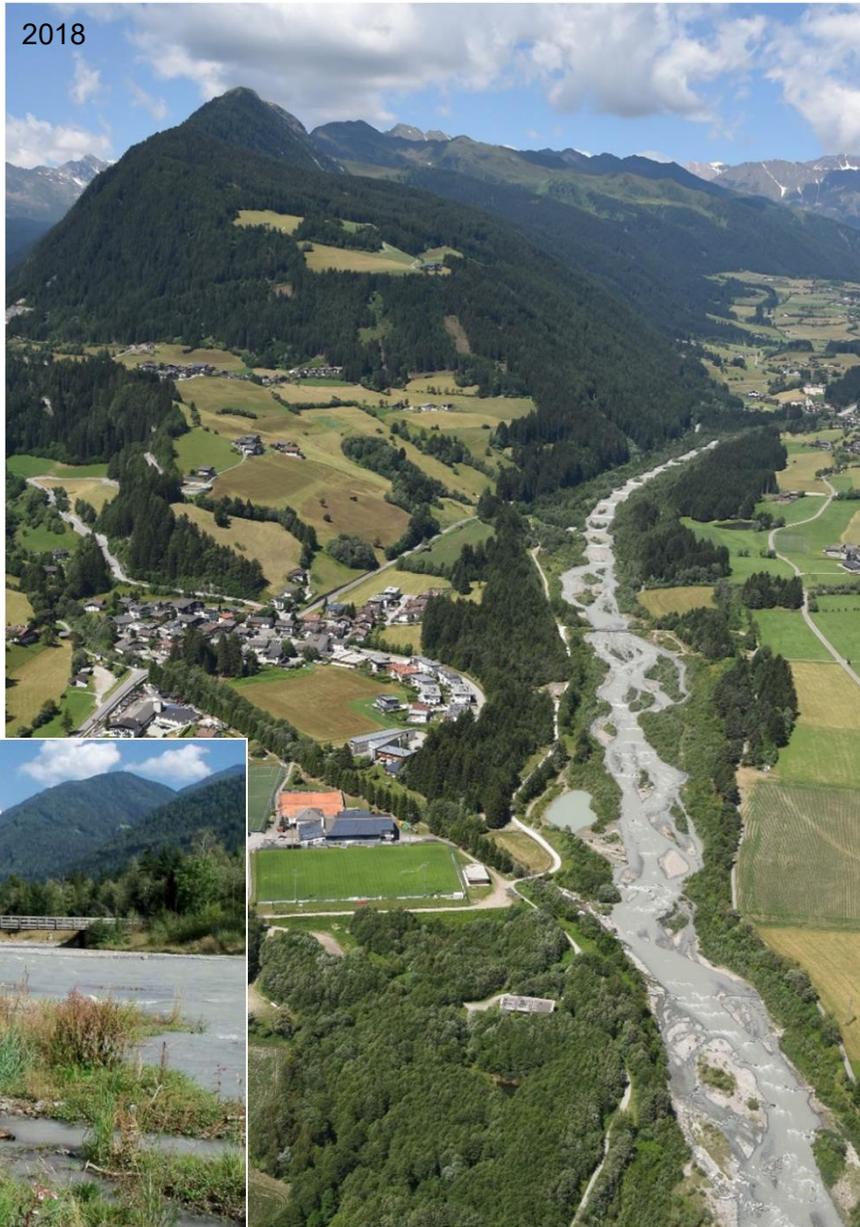
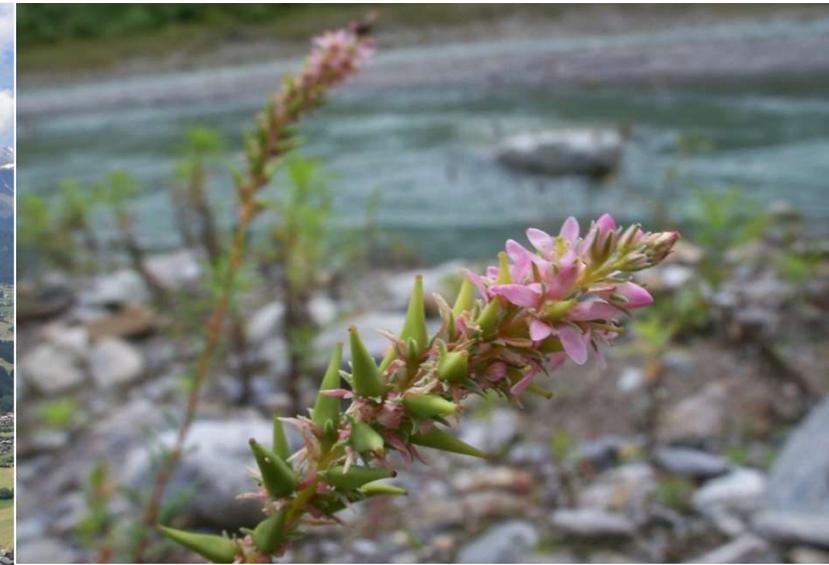
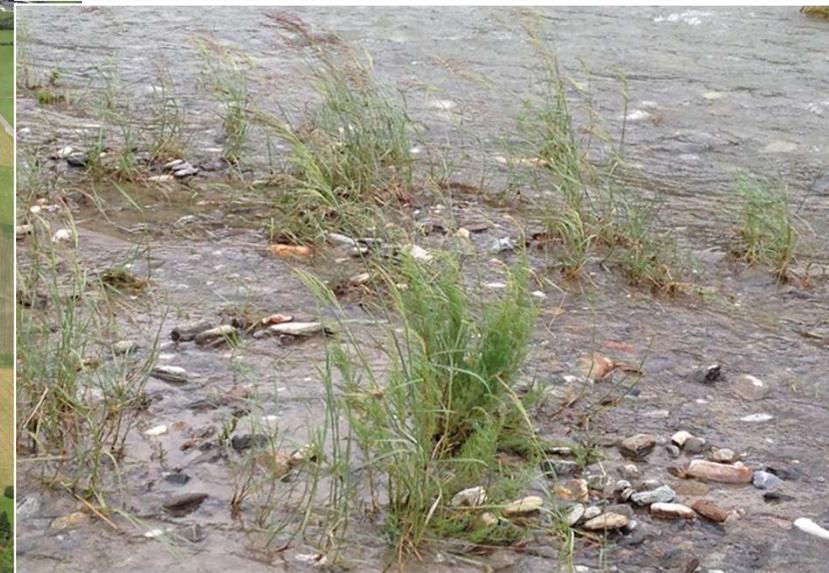
# Ecological effects

Restoration of habitats linked to river dynamics (e.g. depositional habitats for *Myricaria germanica*, hystorically present in the site)

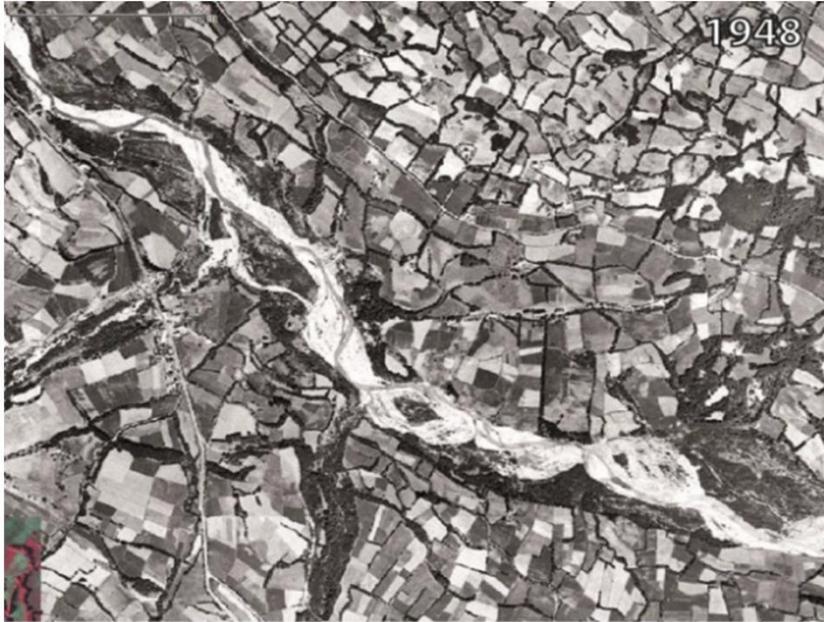
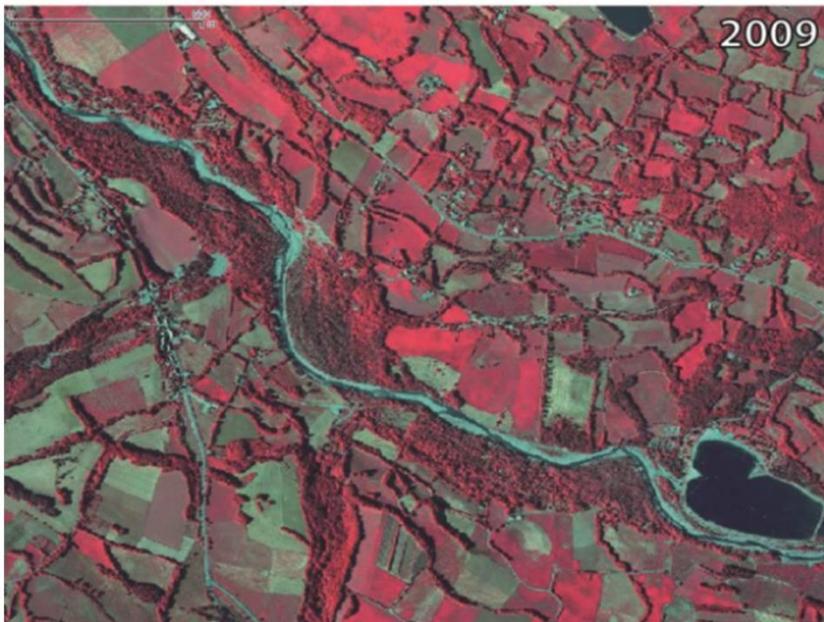
- Massive extraction of sediments (15000 m<sup>3</sup>/y 1970-2012 just upstream the project stretch)
- Mobility corridor from 200 m in 1952 to 45 m max in 2012
- River style from braided to single channel
- Riverbed incision 2-4 m. reaching the clay layer, then quickly 4-5 m
- Regressive erosion, destabilization/loss of functionality of protection works, high risk of collapse of the Champsaur dam
- Disconnection of tributaries
- Lowering of the water table
- Alluvial forest decline

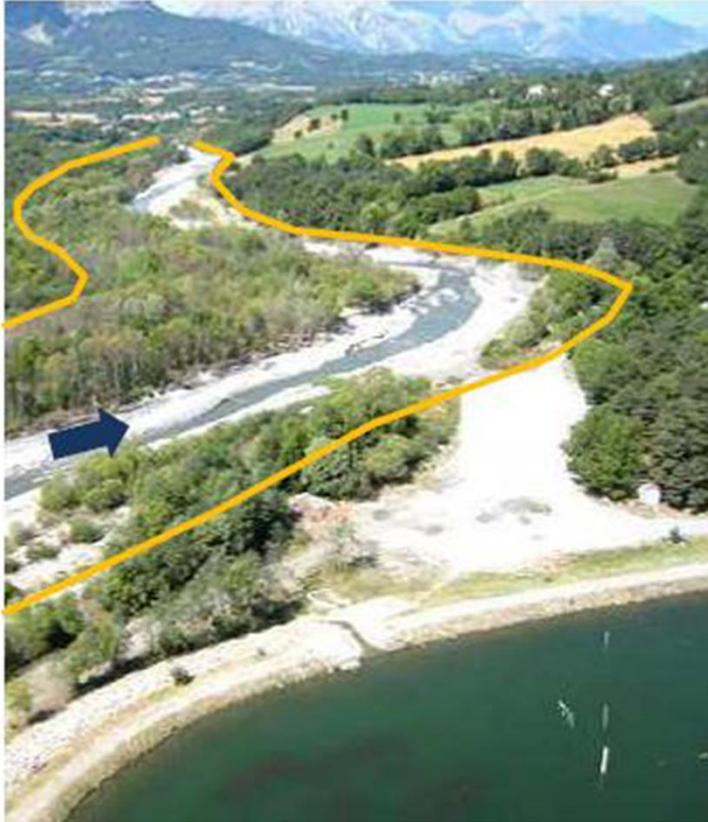
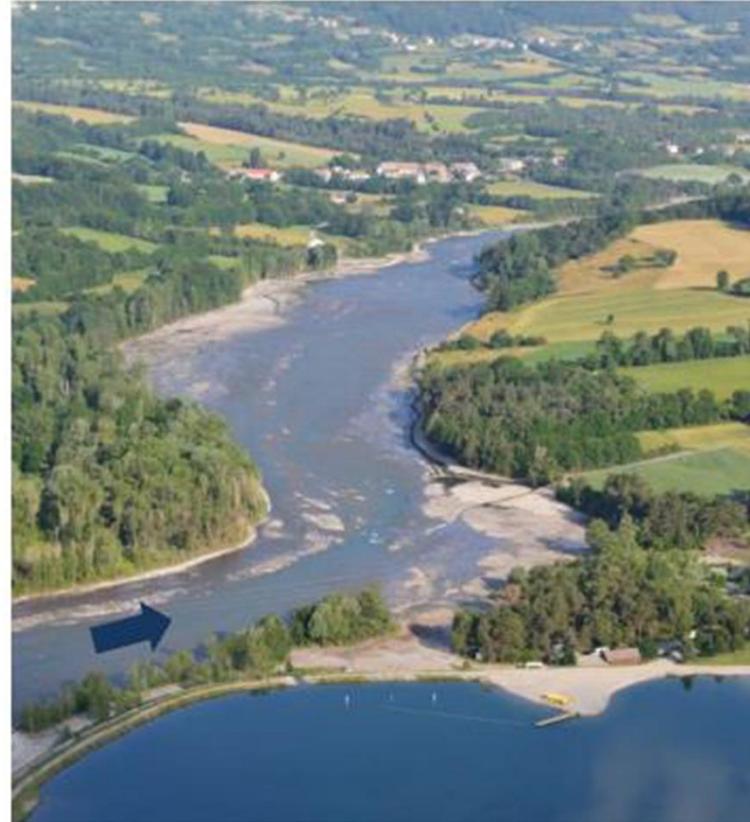
- Largest single gravel reintroduction project in the EU: 450.000 m<sup>3</sup> (390.000 from adjacent alluvial terraces, 60.000 transported from other sources, mainly tributaries)
- Creation of a new wide and shallow channel (100-m wide rectangular cross section, associated with a general rise of the bed-level), leaving the river free to recreate a braided morphology over a length of approx. 3.7 km
- 1.65 m high grade-control weir built at the downstream end of the restored reach, with a fish pass and a canoe pass

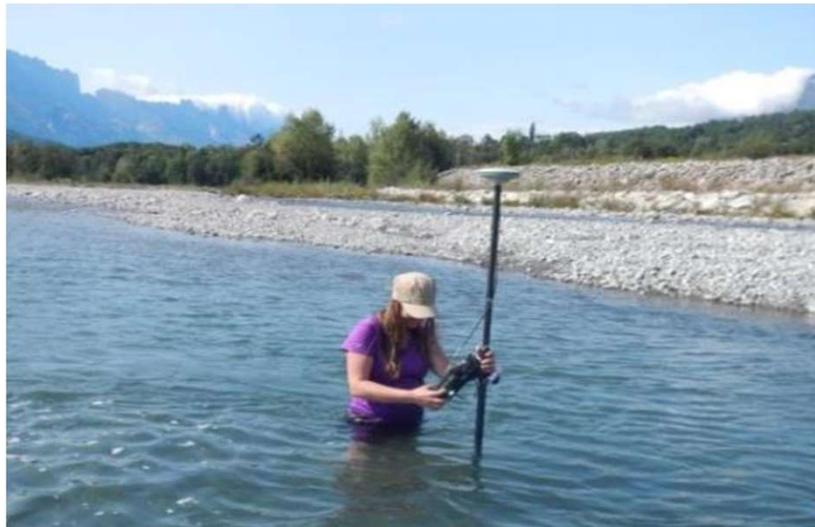
## PHYSICAL MONITORING

- Bedload tracing program using active ultra-high frequency RFID technology
- High-frequency qualitative survey of channel changes using timelapse cameras
- Repetitive high-resolution topographic surveys of the restored reach
- Ancillary field surveys for specific data analysis (e.g. bedload transport computation, calibration of imagery-based data processing)

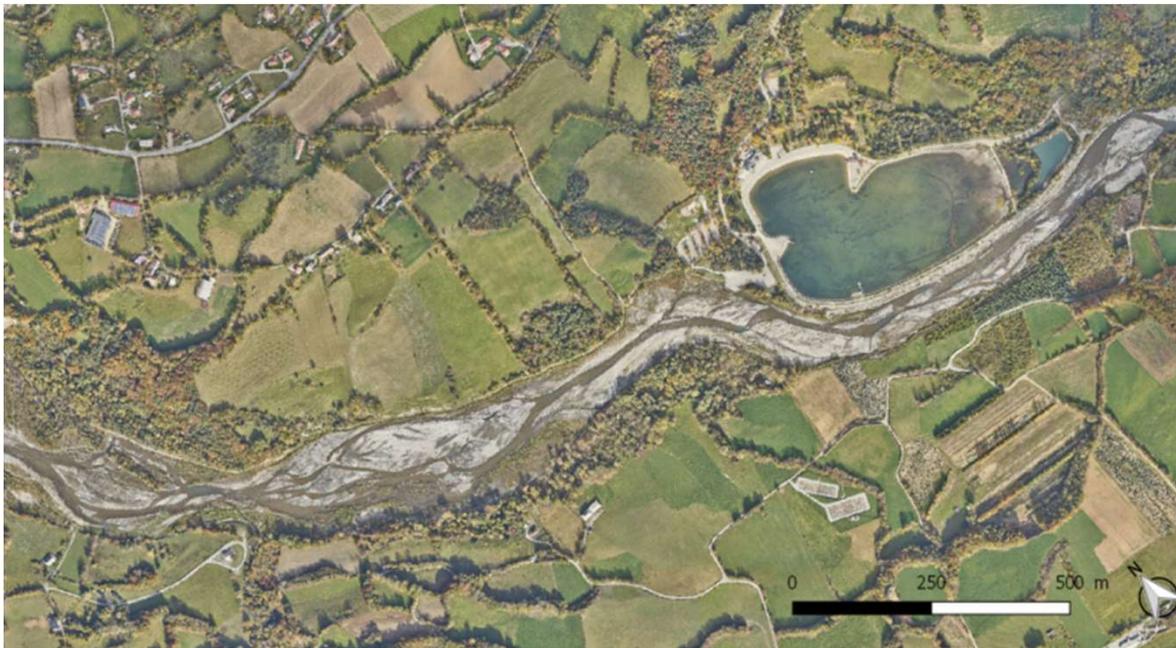
Orthophotographie  
(OPSIA, 2018,  
AERMC)

## MORPHOLOGICAL EFFECTS

First observations of the post-restoration channel evolution reveal a **promising trend towards spontaneous braiding recovery**

- The bedload tracing program shows a **rapid transfer of gravel from the first upper sediment source of the restored reach (the braided Chabottes plain)**

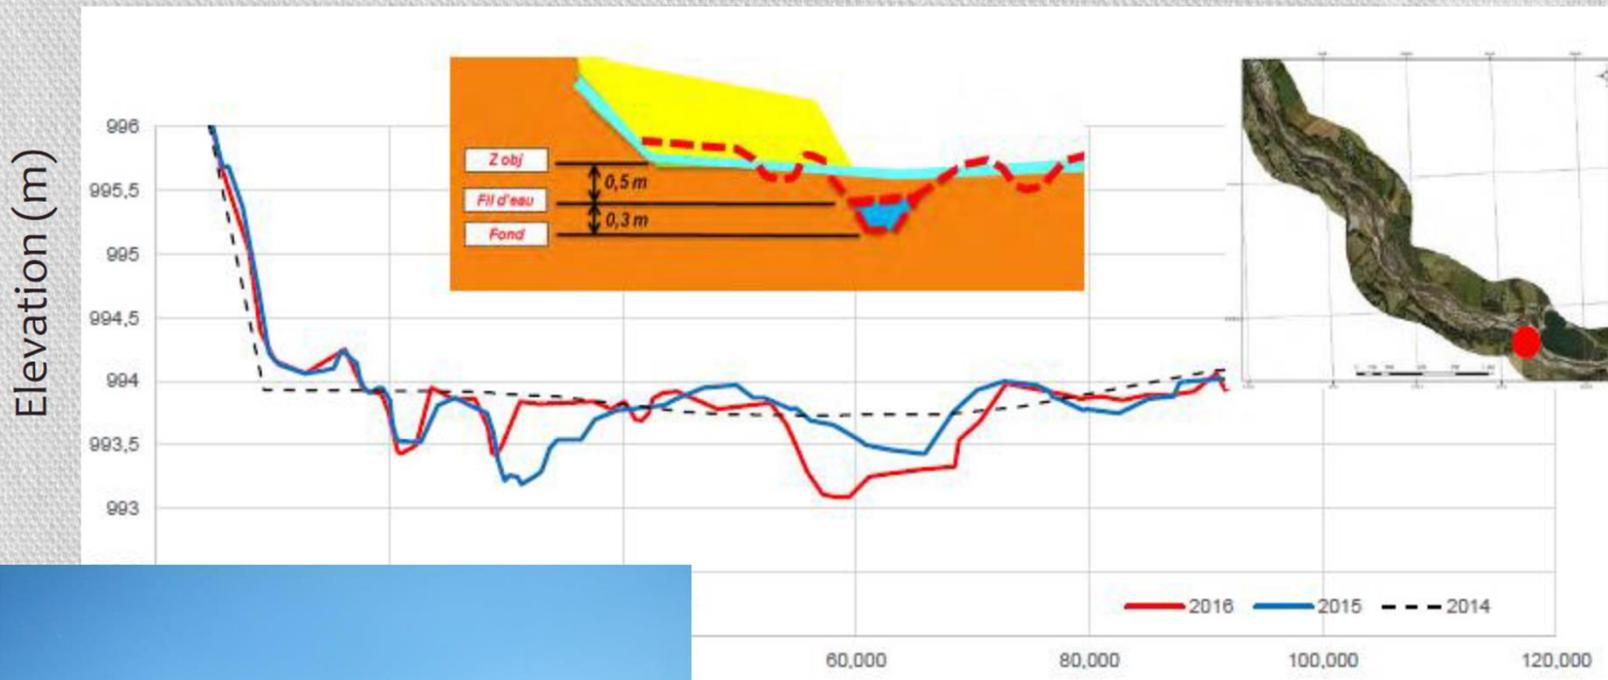
- Formation of channels on the upstream part of the restored reach

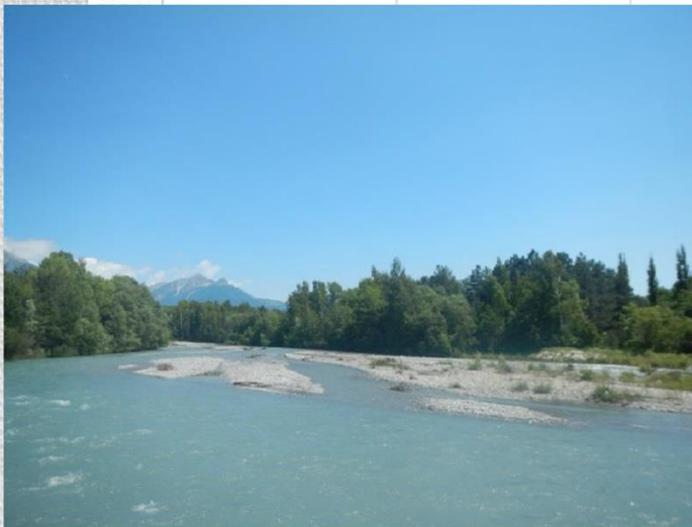
Laval et al. 2017 TSMR

# Post-restoration sediment remobilization

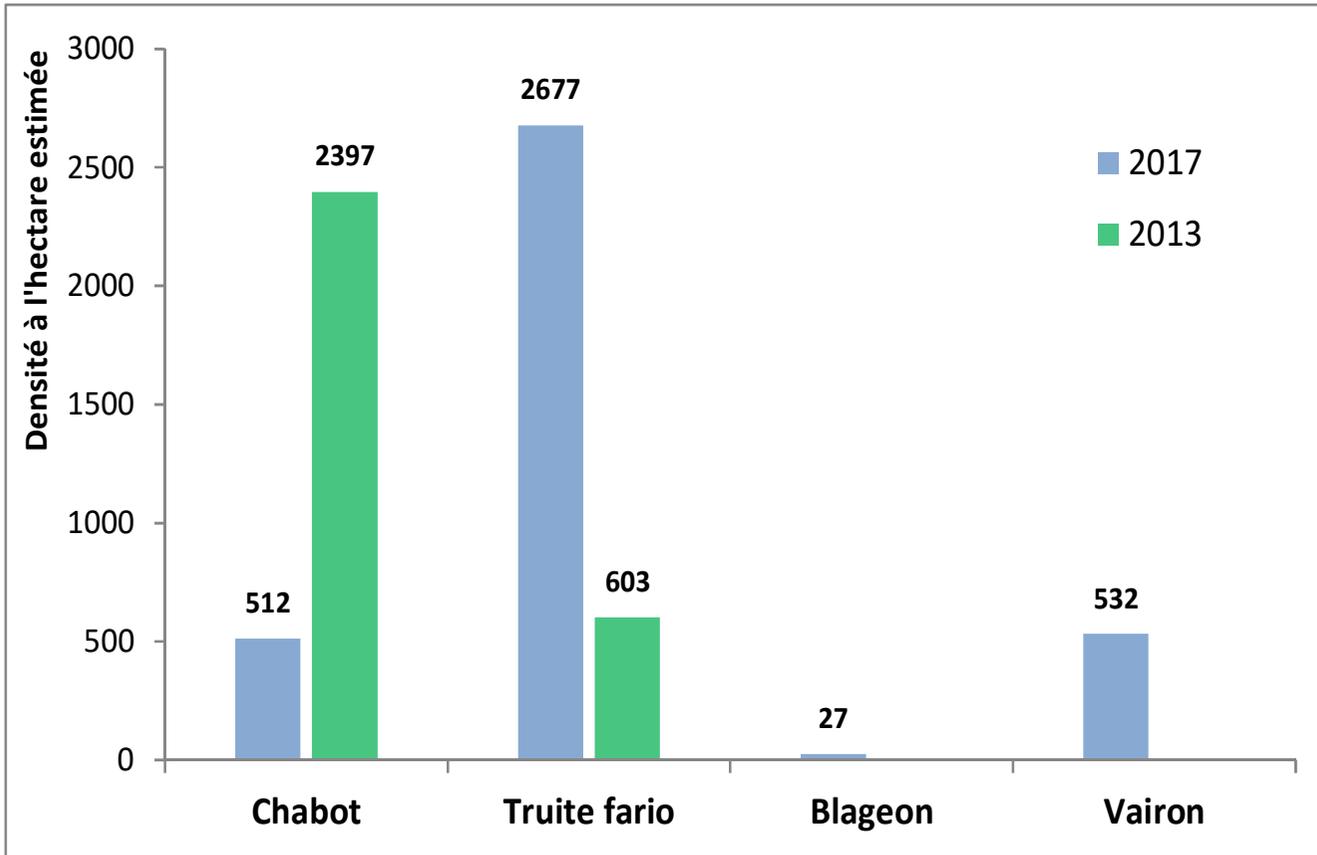
Fish population in 2013 (before restoration) and in 2017 (after restoration) in the restored reach, based on electrofishing by ONEMA

**Now 4 species instead of 2 (2 more termophilic)**

**Brown trout significantly increased, but bullhead decreased**

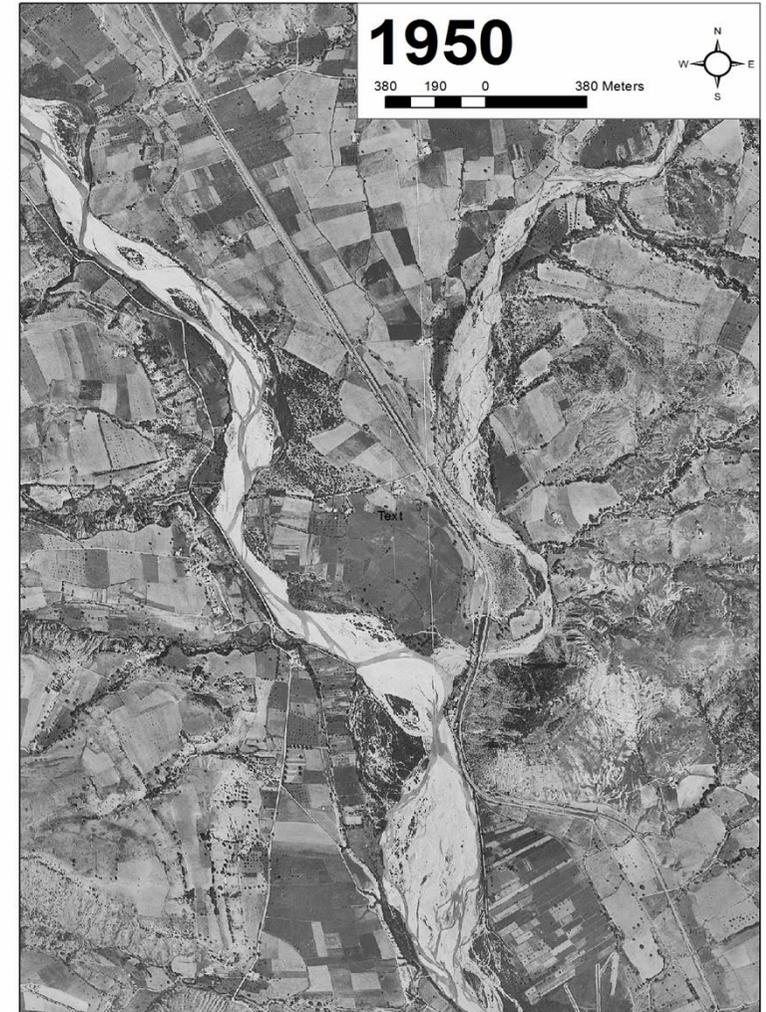
## Human alterations of the physical fluvial corridor

Gravel mining (3 Mm<sup>3</sup> - 6 Mm<sup>3</sup>)

River regulation (dykes)

Saint Sauveur dam (1992)

Bedload has been strongly impacted

→ **Strong channel responses**

→ Alluvial fan is aggrading upstream the reservoir  
(**flood risk**)

Narrowing and degradation of the active channel  
with downstream propagation

Marly bedrock outcrops are observed along the  
degraded reach

A shift from a braided to a wandering pattern
