# The HyMoCARES project: improving hydromorphological management of alluvial rivers

Andrea Goltara – Italian Centre for River  
Restoration (CIRF)

Workshop on Implementation of  
Nature-based Solutions to tackle climate change

# (1) Restoration of the Rio Mareta

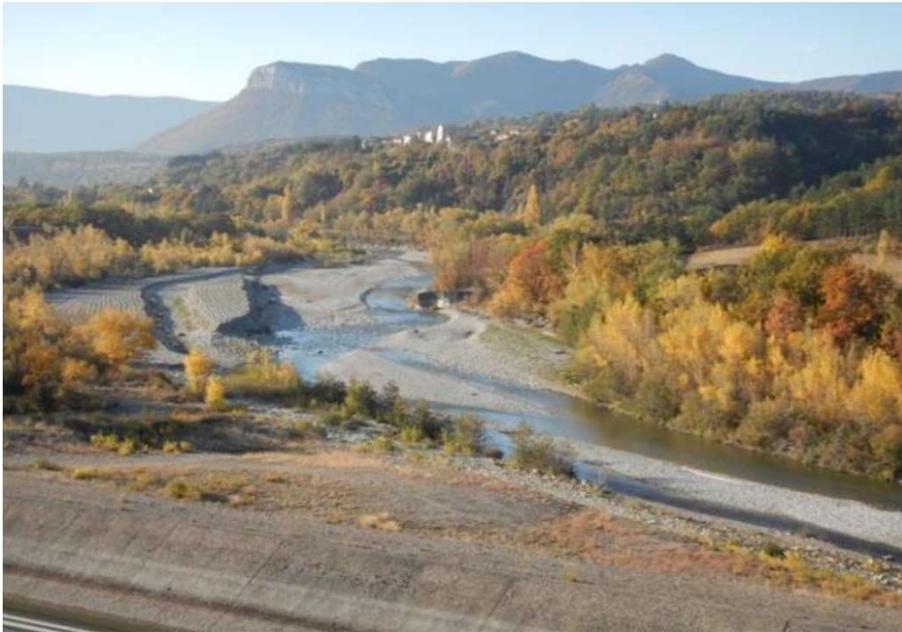
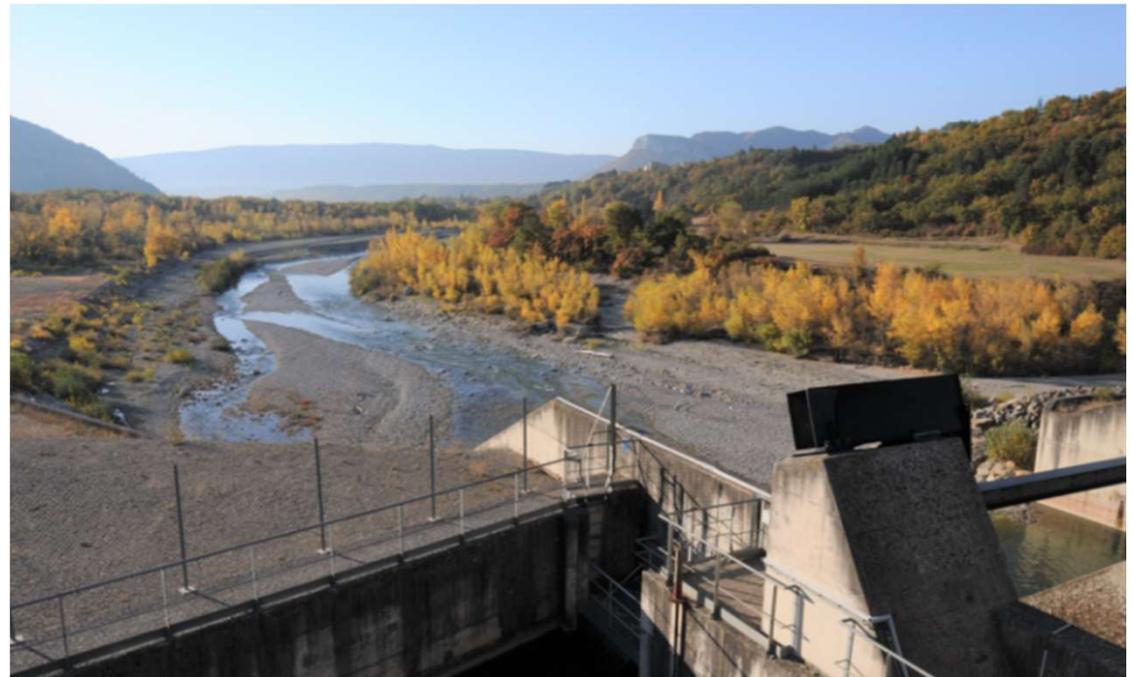
- **Flushing when  $Q > Q_{\text{threshold}}$  before 2015: transparency for  $Q > 80 \text{ m}^3/\text{s}$  (without forecast); from 2015 : transparency for  $Q > 60 \text{ m}^3/\text{s}$  (according to forecast on 24h)**
- **Mechanical reintroduction of gravel dredged in the alluvial fan of the Saint-Sauveur reservoir. September 2016: 44.000 m<sup>3</sup>, 0,5 M€**

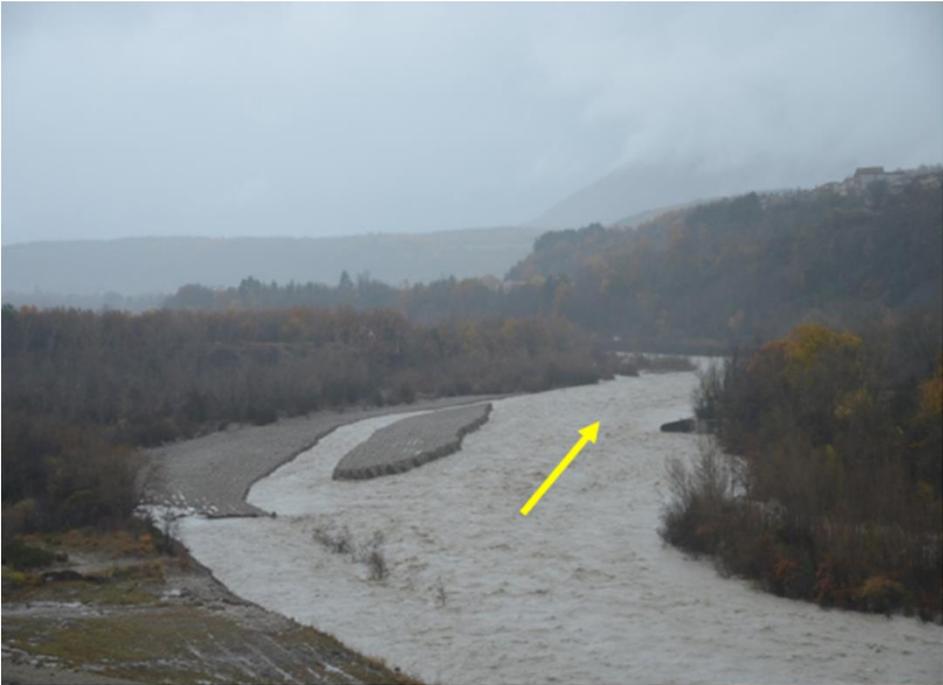
Berms erosion

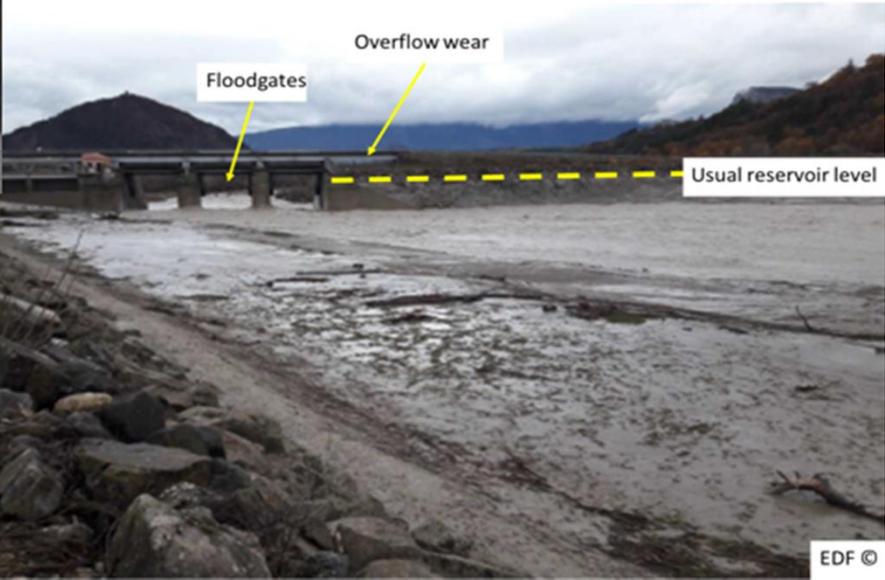
Hydraulic transparency

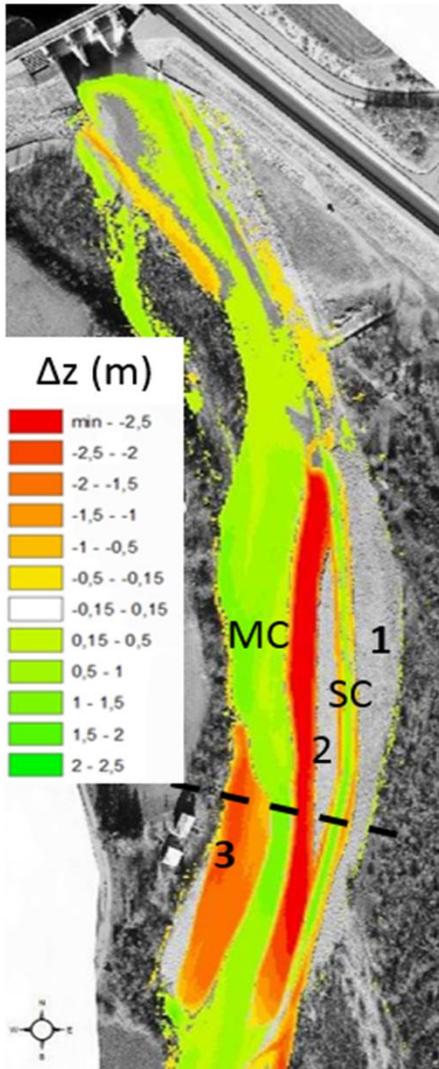
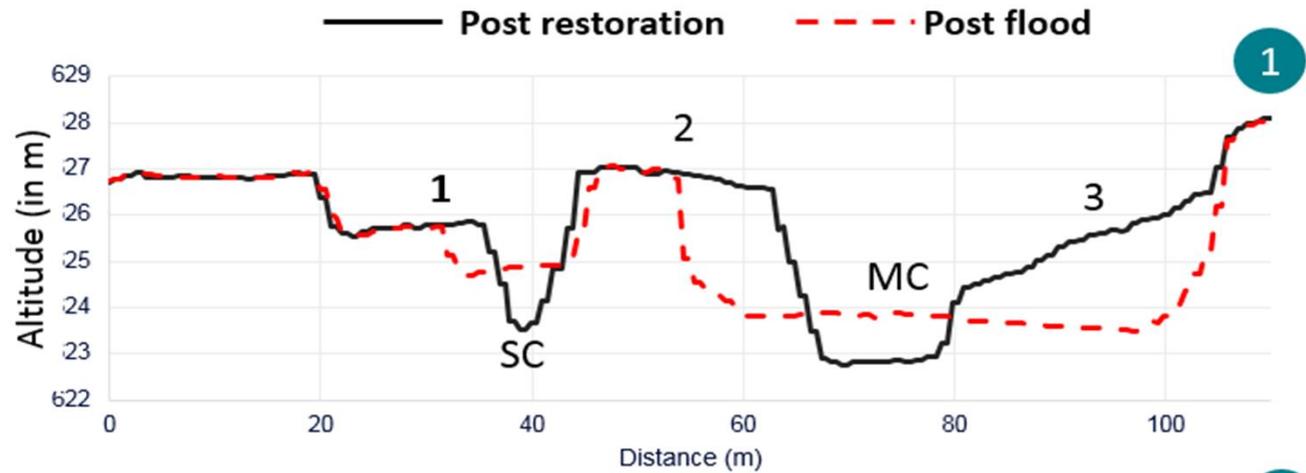
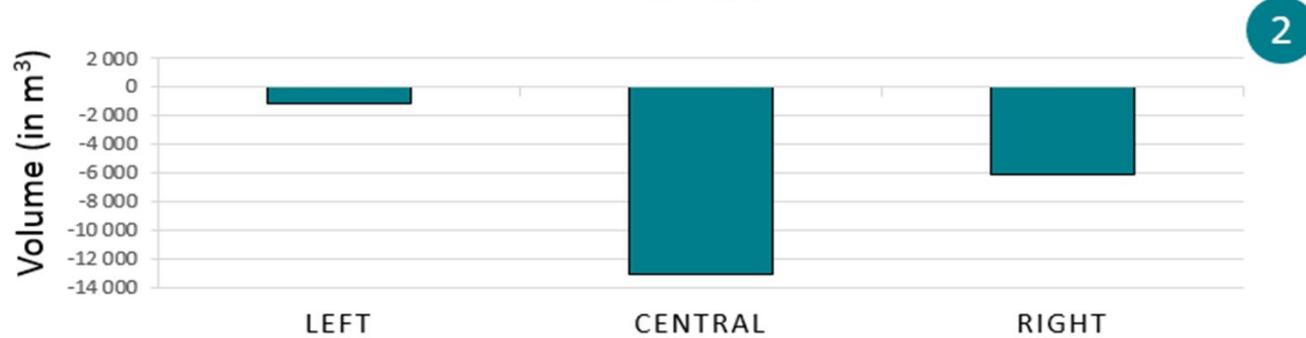
**Very high erosion on the central and on the right berm during flood  
 → 20,000 m<sup>3</sup> (46% of initial berms)  
 Net sediment budget → -11,000 m<sup>3</sup>**
